DREHR PLACE HISTORIC BUILDING SURVEY

PREPARED BY THE LOUISIANA DIVISION OF HISTORIC PRESERVATION FEBRUARY 2005

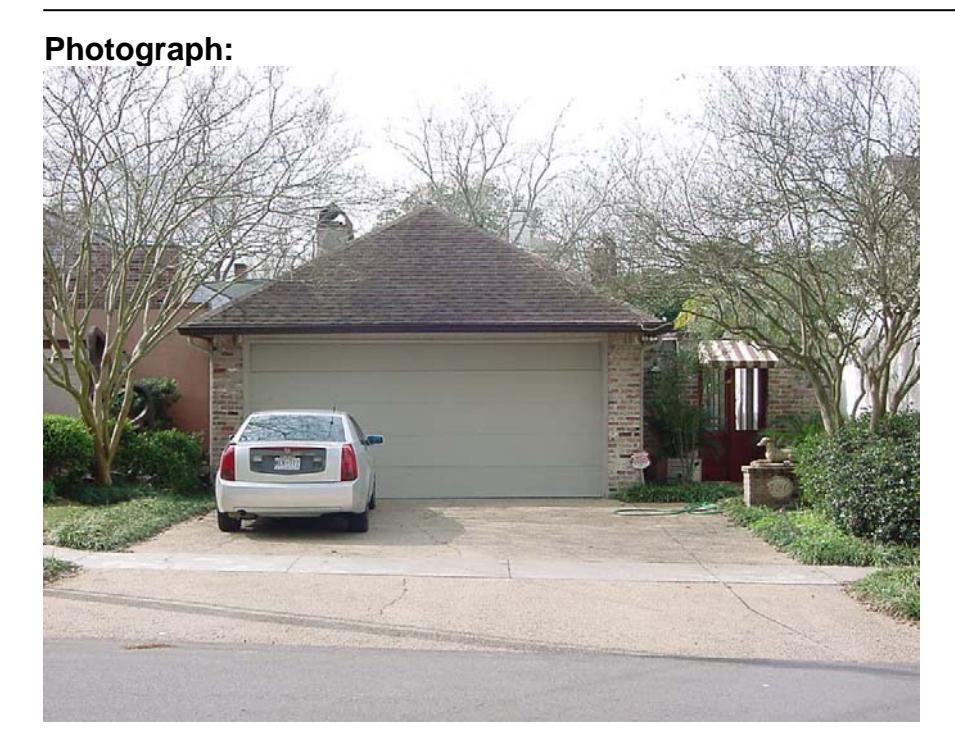
Building Address: 520 Drehr Avenue				
Map/Parcel: 2				
Listed on National Register? No In N.R. Historic District? Yes				
Date:				
Photo/Map Sources: Division of Hisoric Preservation				
Date of Survey:February 2005Surveyor:Division of Hisoric Preservation				
Historic Information: Non-contributing. 1980s one story patio home.

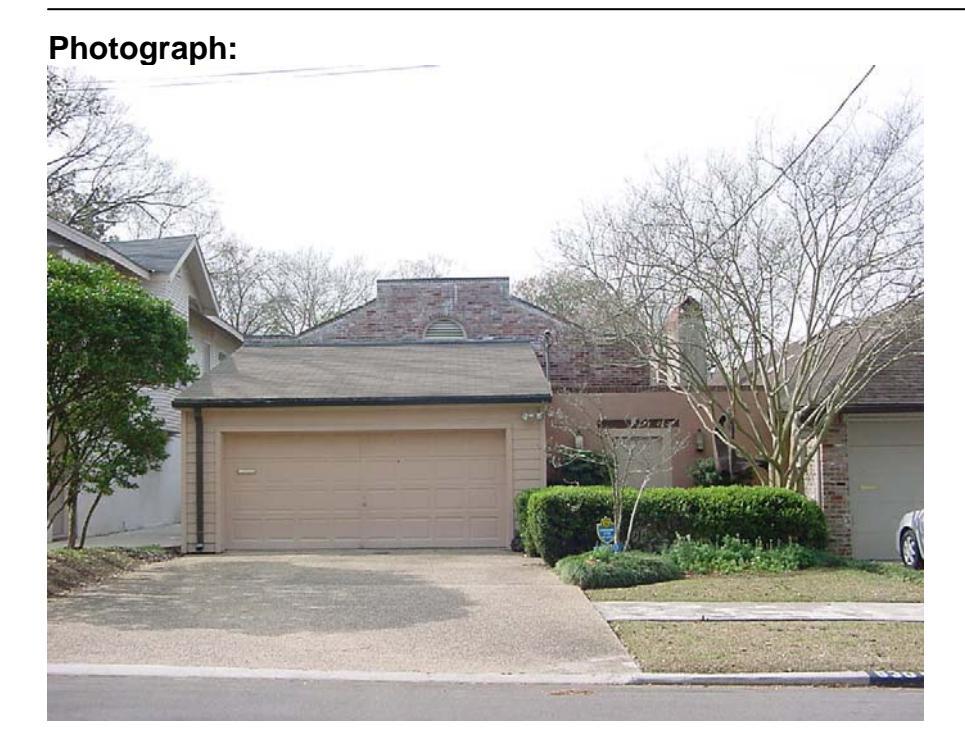
Building Address: 530 Drehr Avenue

Historic Information: Non-contributing. 1980s one story patio home.

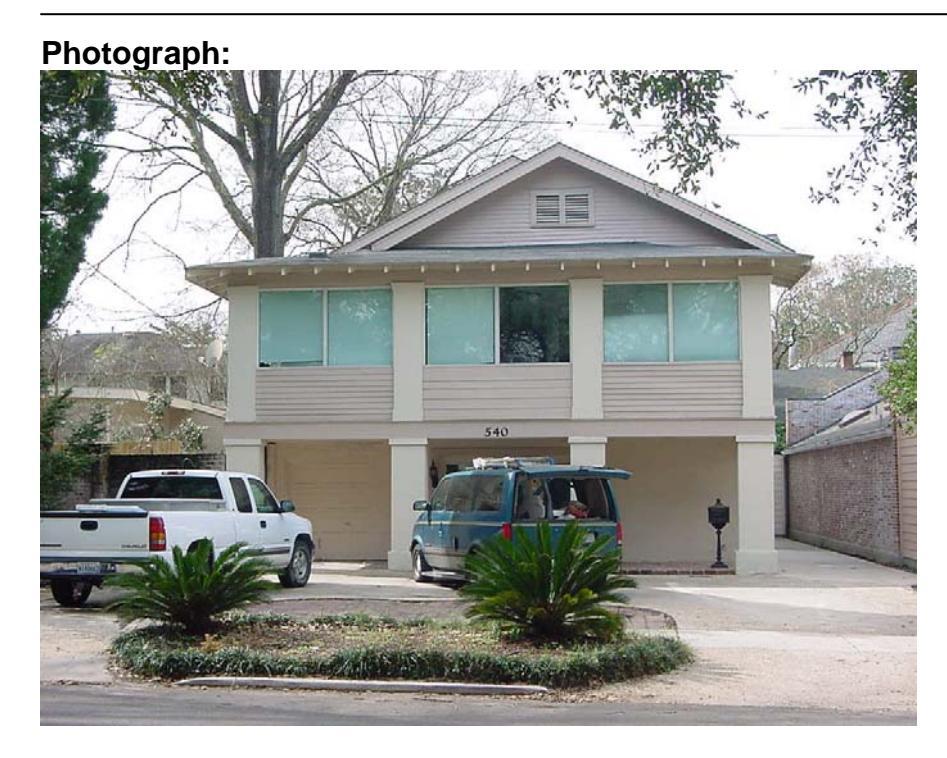
Building Address: 540 Drehr Avenue

Historic Information: Non-contributing. Historic bungalow moved in 1980s from same block, raised a full story, new story built below, and original bungalow remodeled.

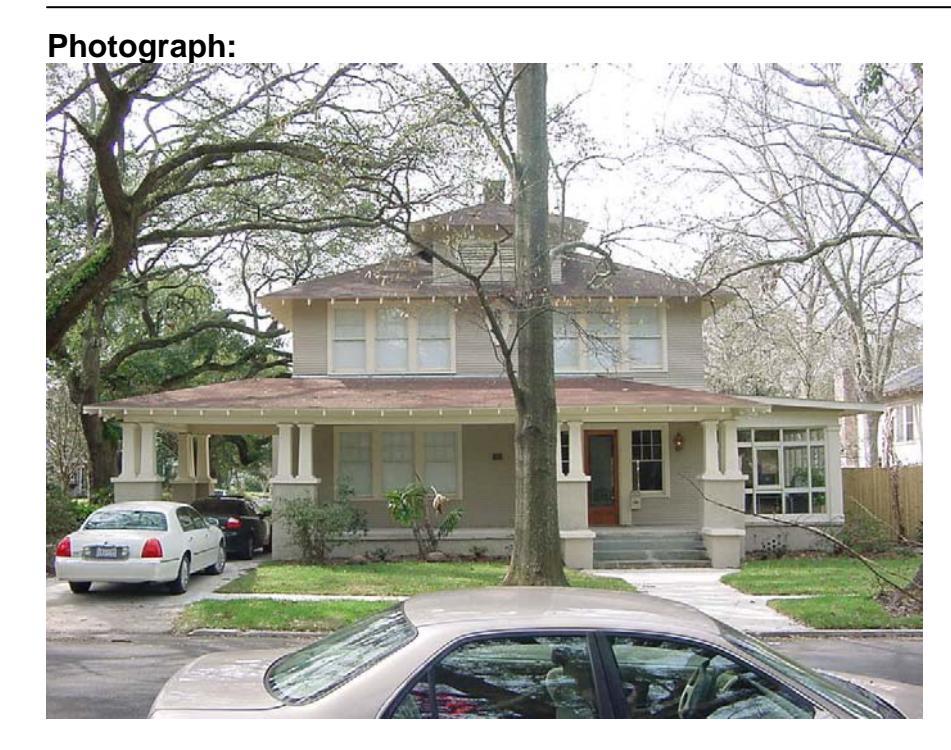
Building Address: 524 Drehr Avenue

Historic Information: Contributing. 1920s two story frame hip roof house with bungalow style porch ending in a porte-cochere. Porch and porte cochere feature brick piers with paired splayed posts atop each.

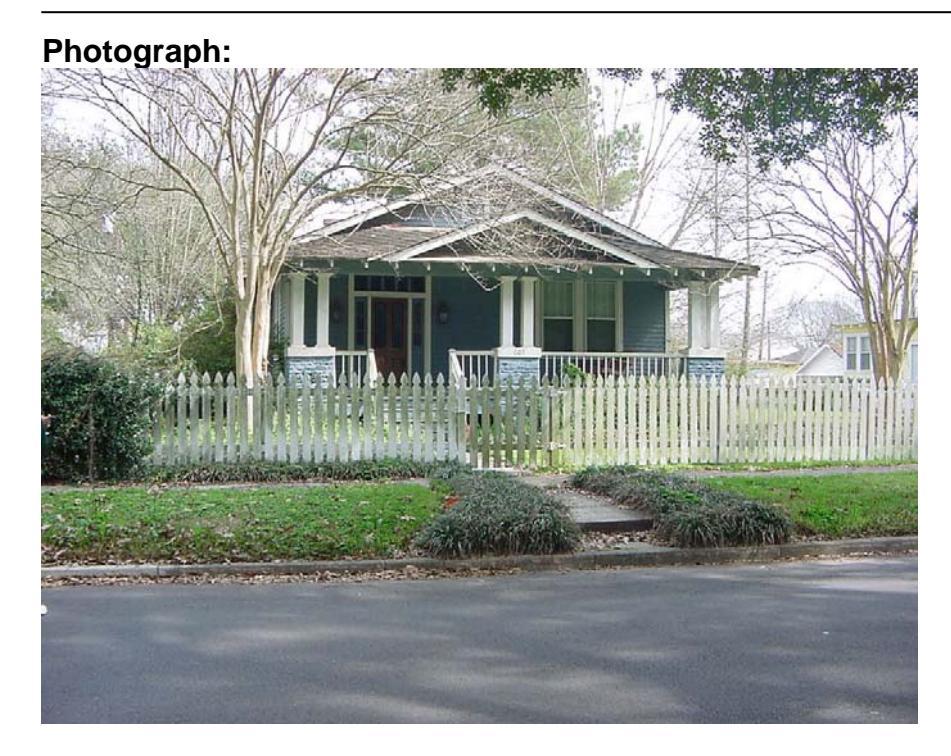
Historic Information: Contributing. 1920s wood frame bungalow with paired posts atop heavily textured brick piers.

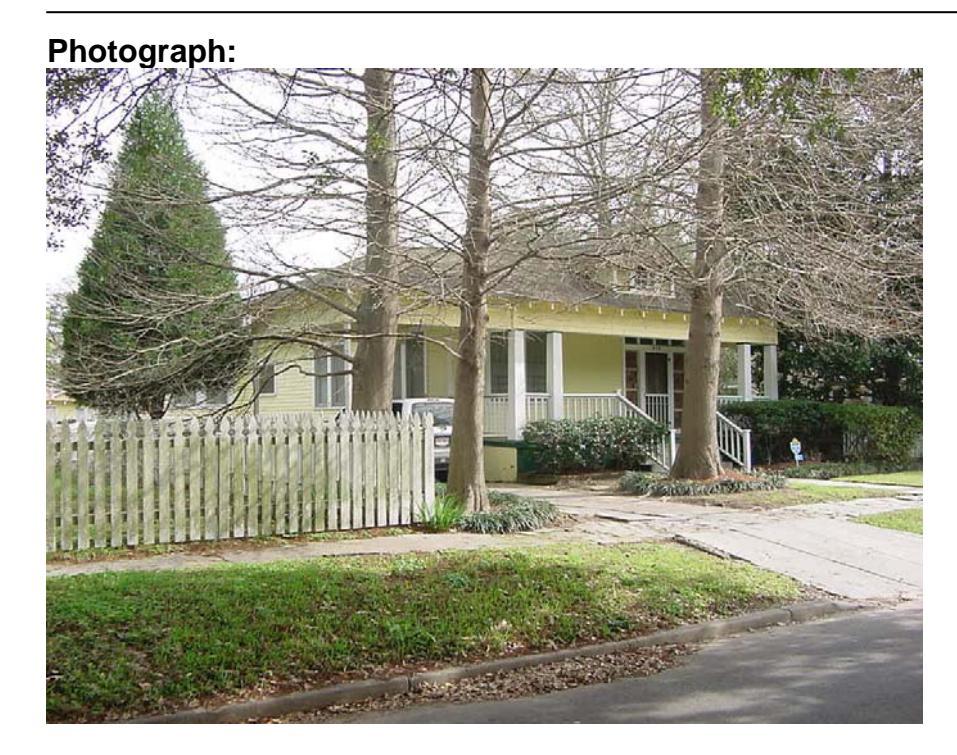
Historic Information: Contributing. 1920s wood frame house with slight bungalow style influence. Porch features paired thick, slightly splayed posts (which do not rest on piers, as is typical of the bungalow style). Balustrade and porte-cochere are non-historic.

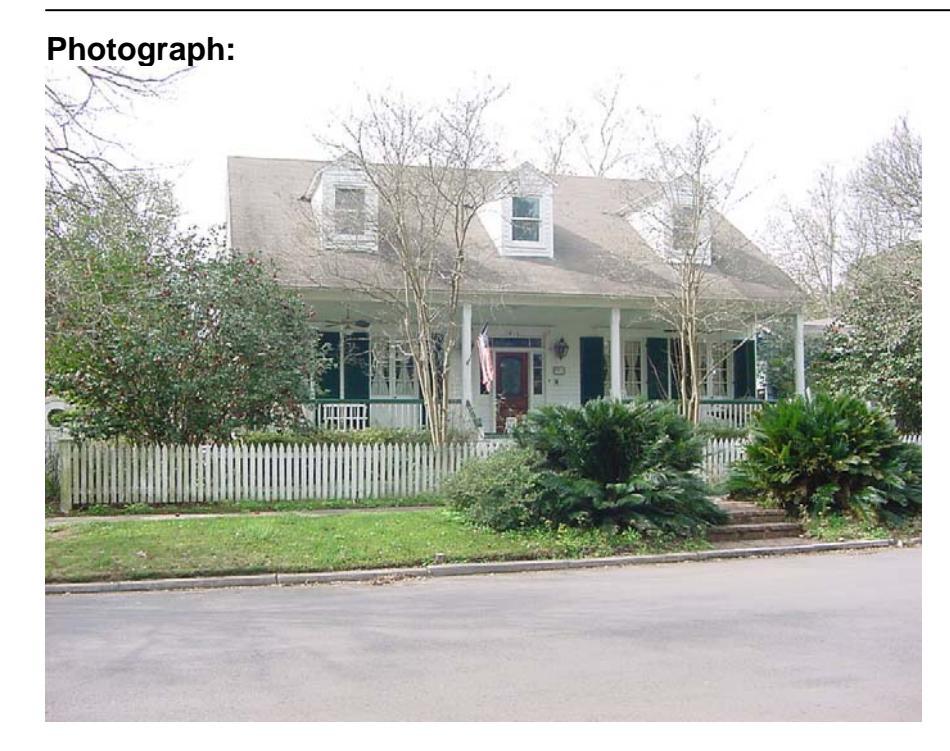
Historic Information: Non-contributing. This frame galleried cottage looks midnineteenth century, making one think it had been moved to this location. However, according to the National Register nomination for Drehr Place, it was built some twenty or so years ago.

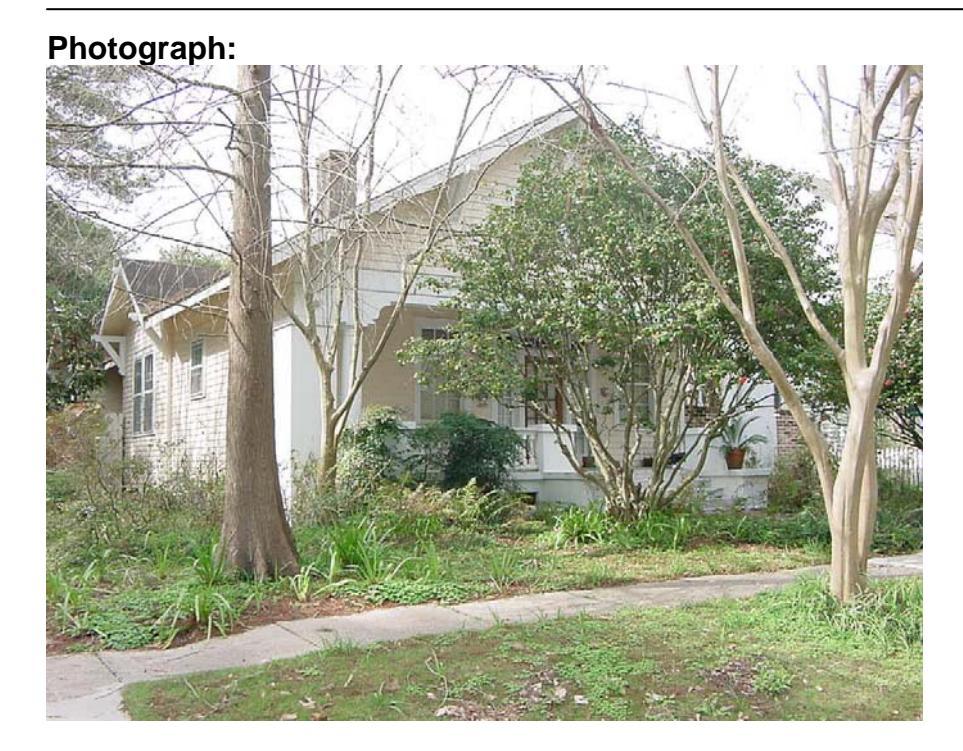
Historic Information: Contributing. 1920s wood frame bungalow with large gable encompassing façade. Gable features brackets at eaves. Porch reflects both the bungalow style and the Colonial Revival. At each corner is a thick brick pier rising from the ground to the eaves with an adjacent wooden Colonial Revival column.

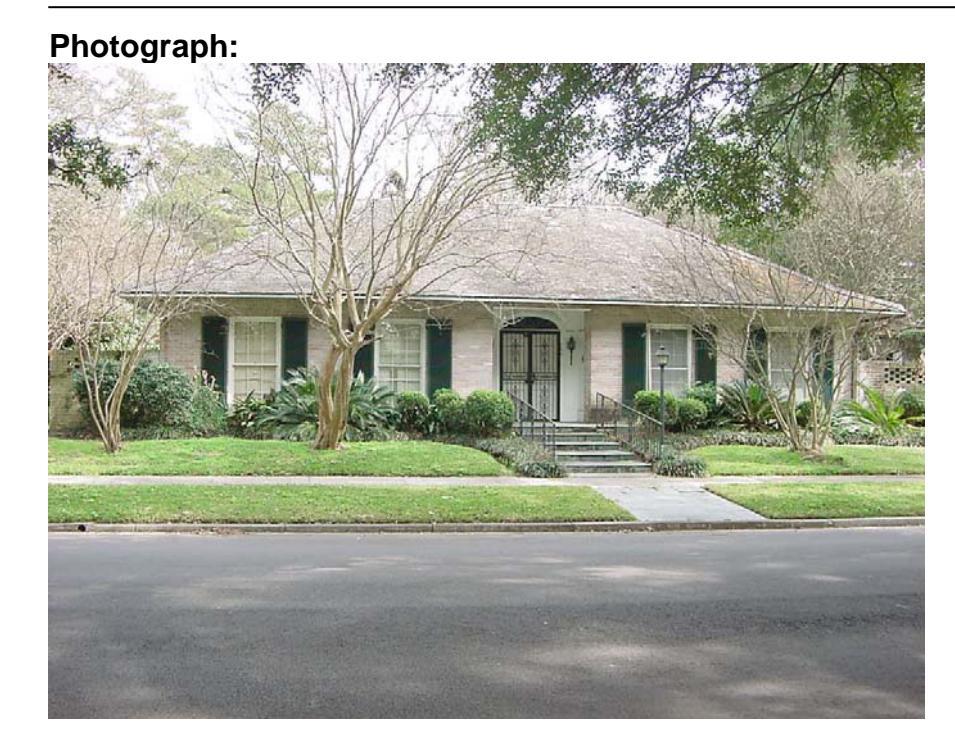
Building Address: 755 Drehr Avenue			
Map/Parcel: 15			
Listed on National Register? No In N.R. Historic District? No			
Date: c. 1960			
Photo/Map Sources: Division of Historic Preservation			
Date of Survey: February 2005 Surveyor: Division of Historic Preservation			
Historic Information: Non-contributing one story 1950s/60s brick house

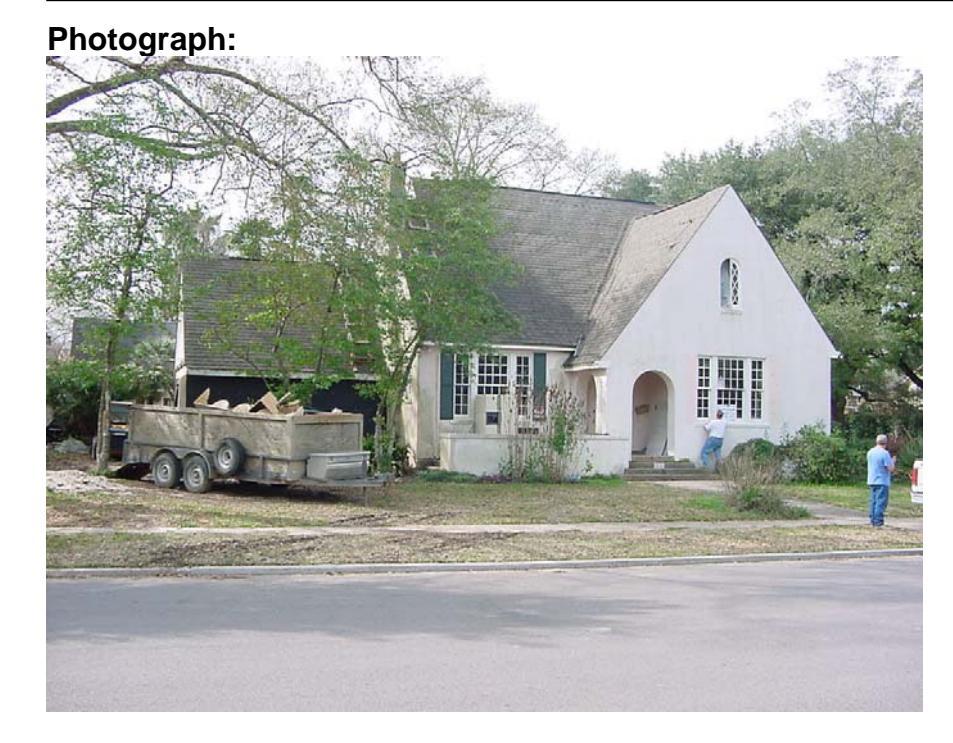
Historic Information: Contributing. 1930s one-and-a-half story stuccoed house in the English Cottage style. Large steeply pitched front gable features an arched window at the top with a simulated diamond pane treatment. Grouped multi-pane windows contribute to the intended "ancient" look. An arched opening leads to the entrance.

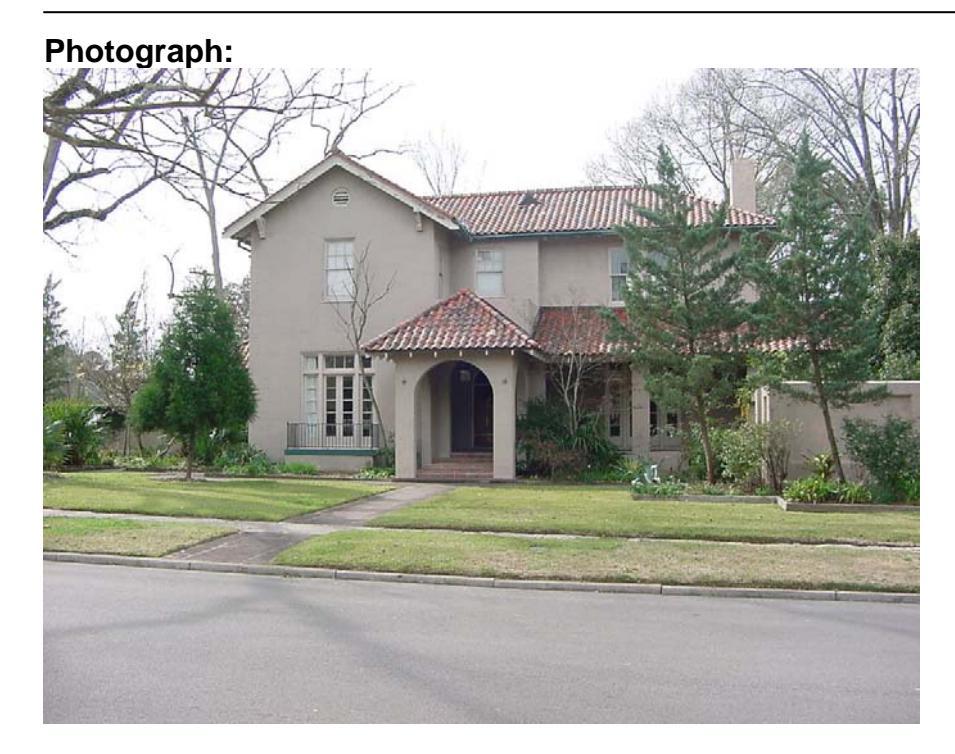
Historic Information: Contributing. Circa 1930 two story, stuccoed house with something of a Mediterranean feel due to a main tile roof and a shed tile roof over a one story porch spanning much of the façade. Forward projecting hipped roof entrance pavilion appears to be an addition. (It too has a tile roof.)

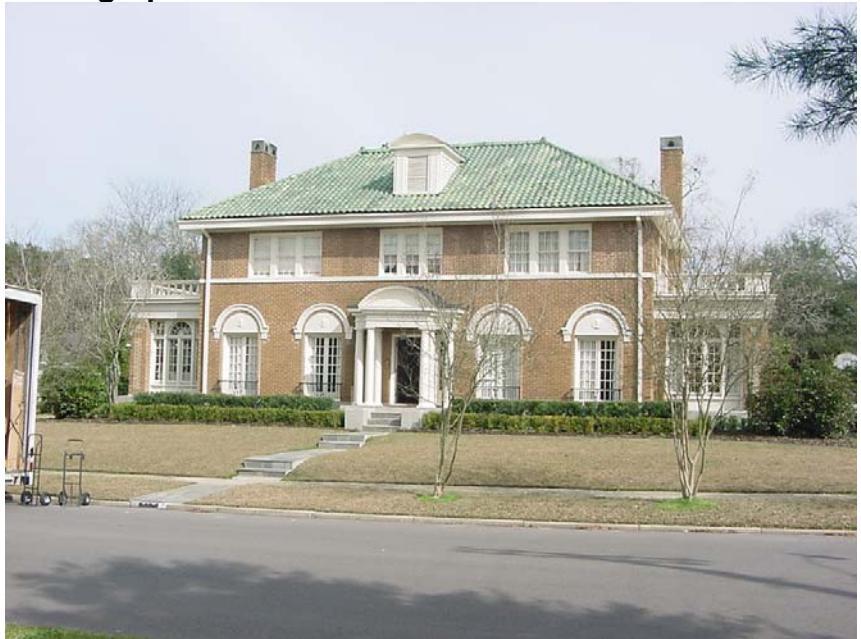
Historic Information: Contributing. Circa 1930 two story Italian Renaissance beige brick house with a spreading green tile roof, upper stories incorporated into a wide frieze-like band, and pronounced round head windows with blind arcades. The rather grand house culminates in a handsome entrance portico with a segmental pediment and Tuscan columns. A richly articulated one story sunroom with a balustrade at the top is found on each side of the façade. (This is perhaps Drehr Place's most impressive architectural landmark.)

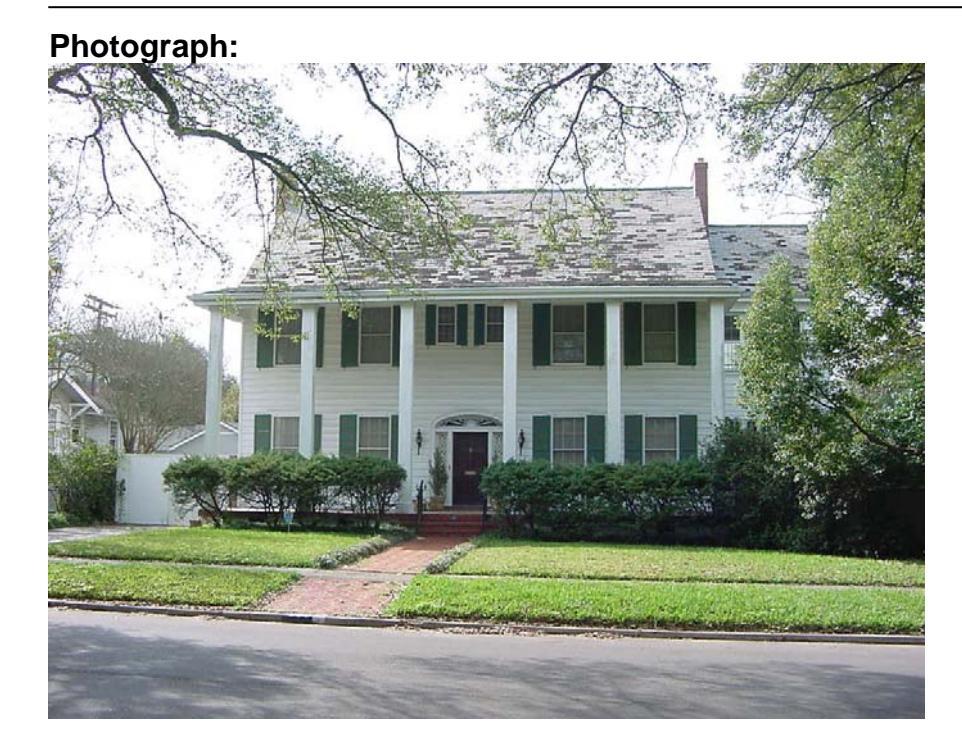
Historic Information: Contributing. Circa 1940 two story vinyl or aluminum sided Colonial Revival house with a colossal Mt. Vernon portico spanning façade of the main block; Federal style elliptical transom and sidelights highlight entrance.

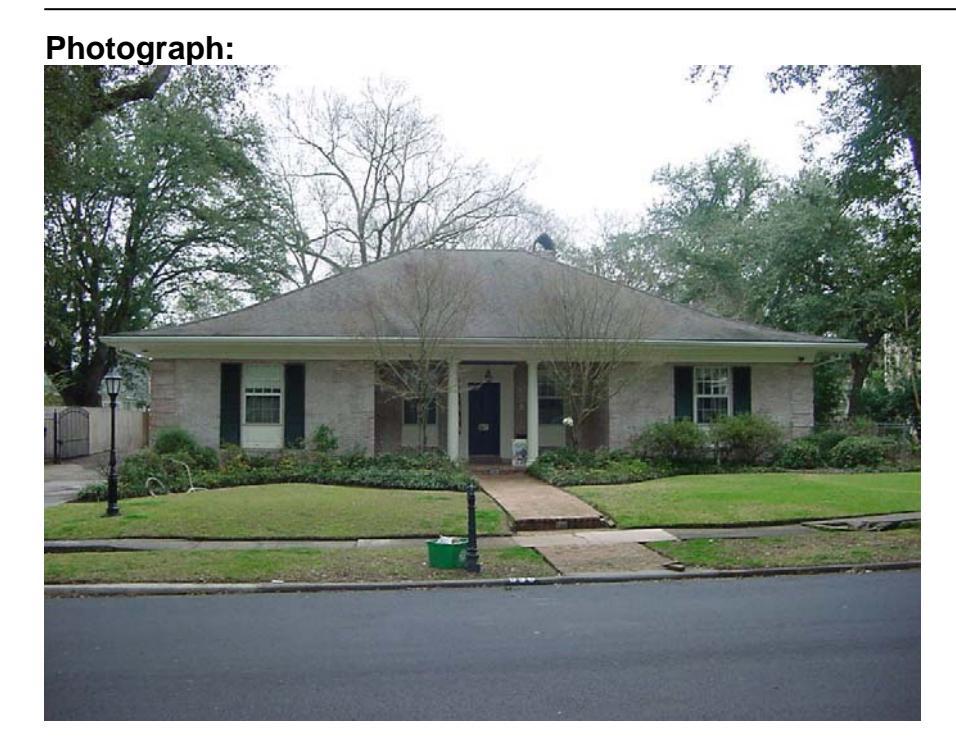
Building Address: 935 Drehr Avenue

Historic Information: Non-contributing one story brick house dating from 1950s/60s.

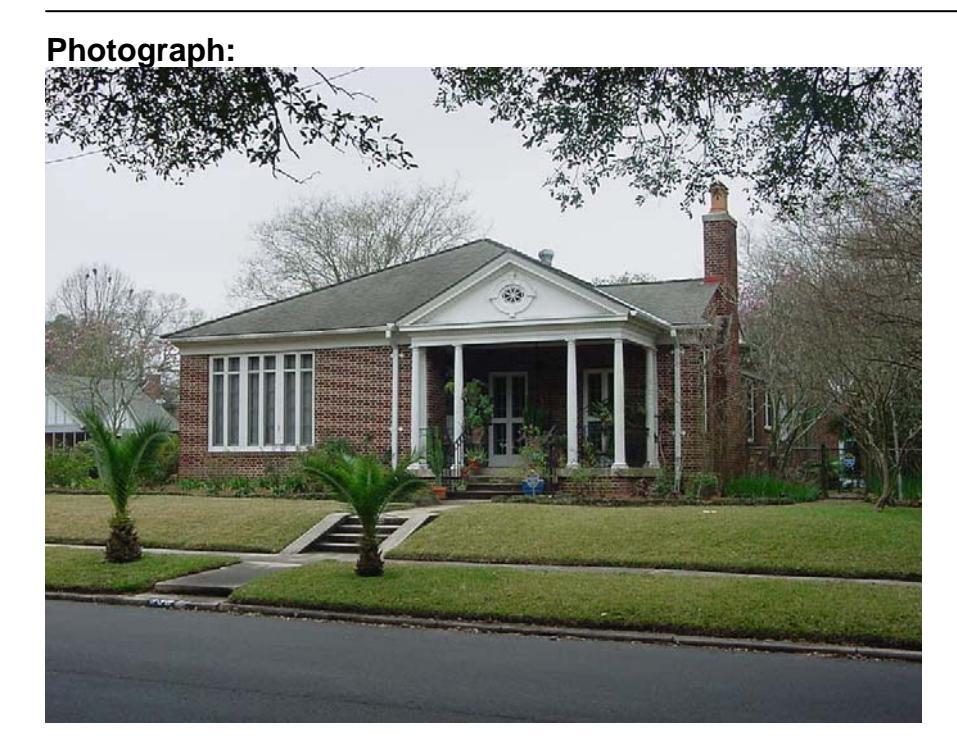
Historic Information: Contributing. 1940s Colonial Revival one story red brick house with asymmetrically placed pedimented entrance portico painted a contrasting white. Slender paired columns support the pediment; at center of pediment is a strongly articulated oculus window.

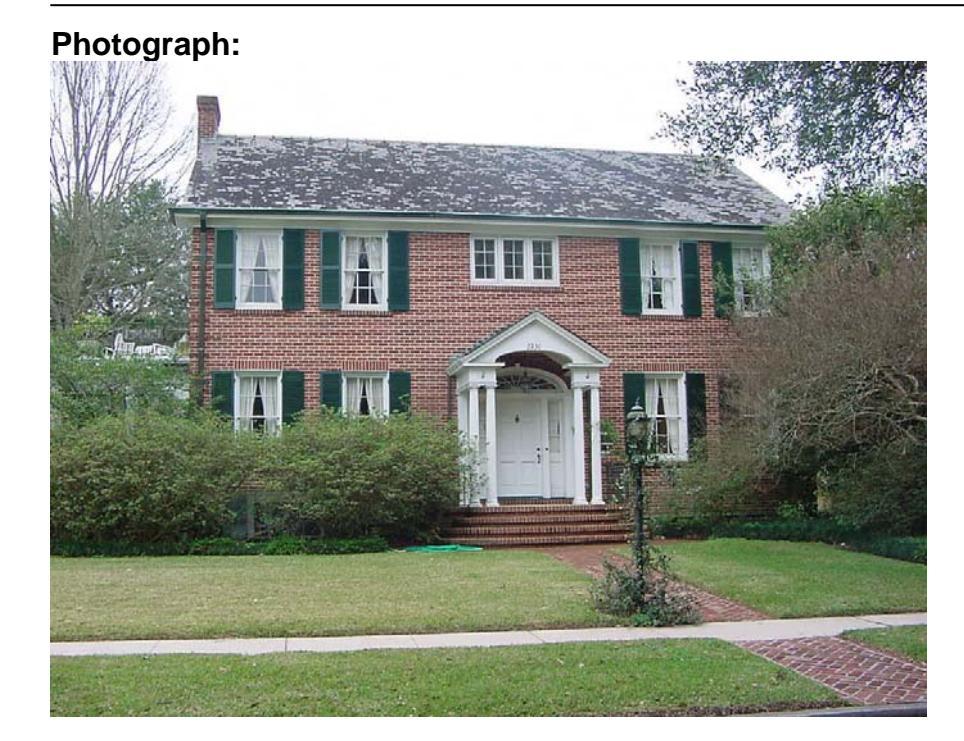
Historic Information: Contributing. 1930s two story, symmetrically articulated red brick house inspired by American Federal architecture. Handsome entrance portico features slender paired columns and a pediment broken by a shallow arch. Arch echoes elliptical fanlight of doorway behind.

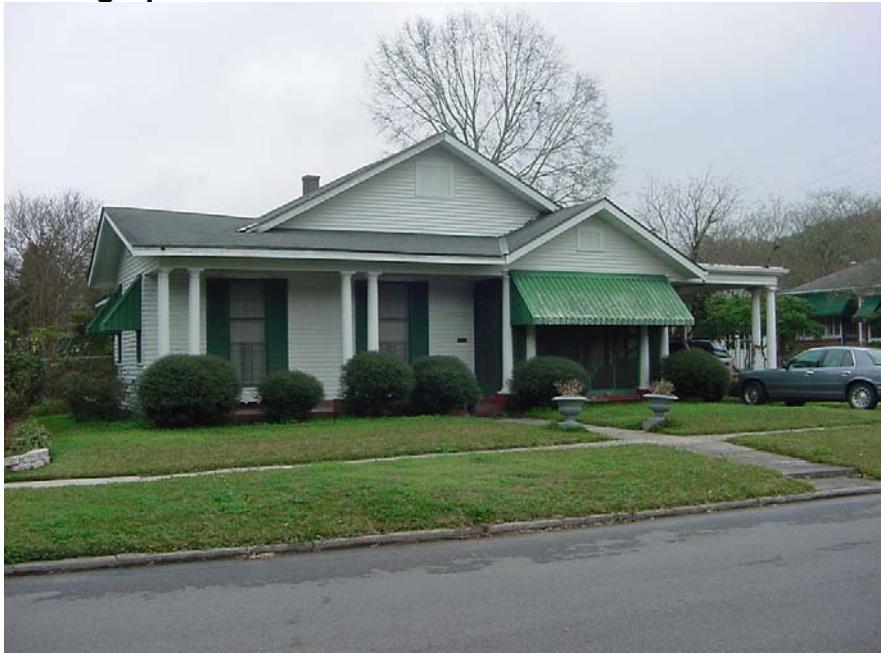
Historic Information: Contributing. Severely altered one story historic house (synthetic siding, columns replaced). Contributes due to its massing and overall street presence.

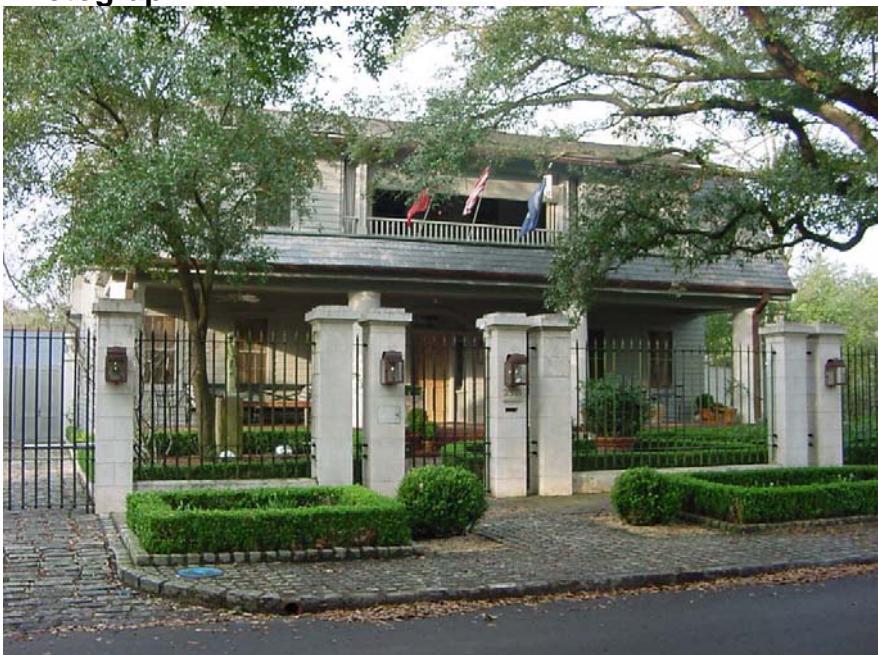
Historic Information: Contributing. 1930s one and a half story wood frame Colonial Revival house with a massive gambrel roof featuring a large pent dormer. Pent dormer provides for a balcony. Front door features an elliptical fanlight. Large, bulbous stuccoed porch posts may be replacements.

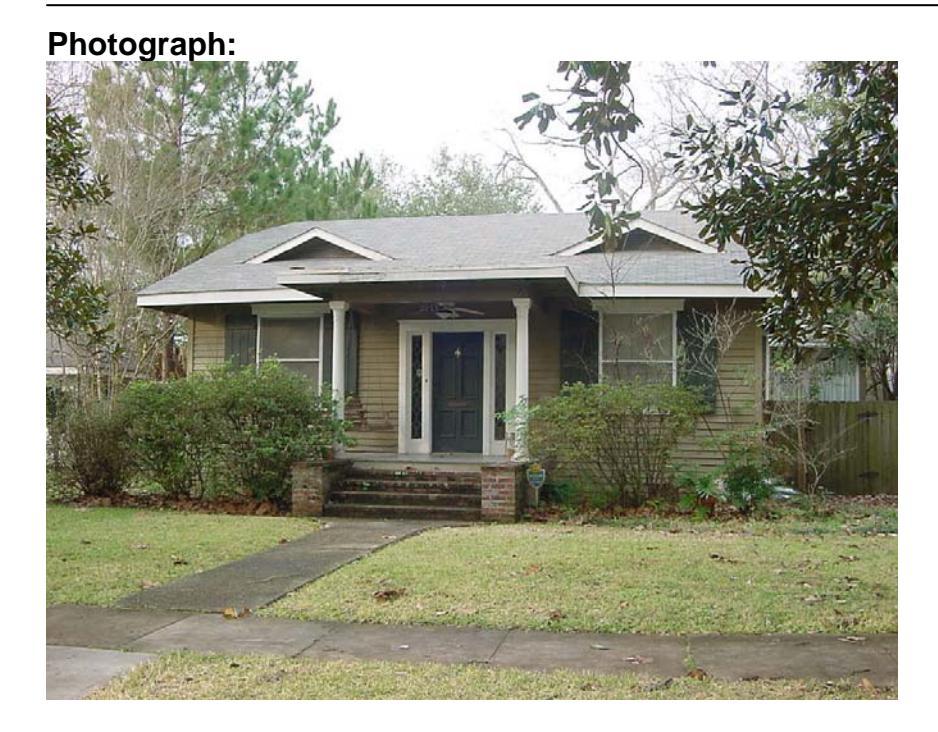
Historic Information: Contributing. 1920s one story frame unstyled cottage. Colonial Revival style columns on porch (one at each corner) appear to be replacements.

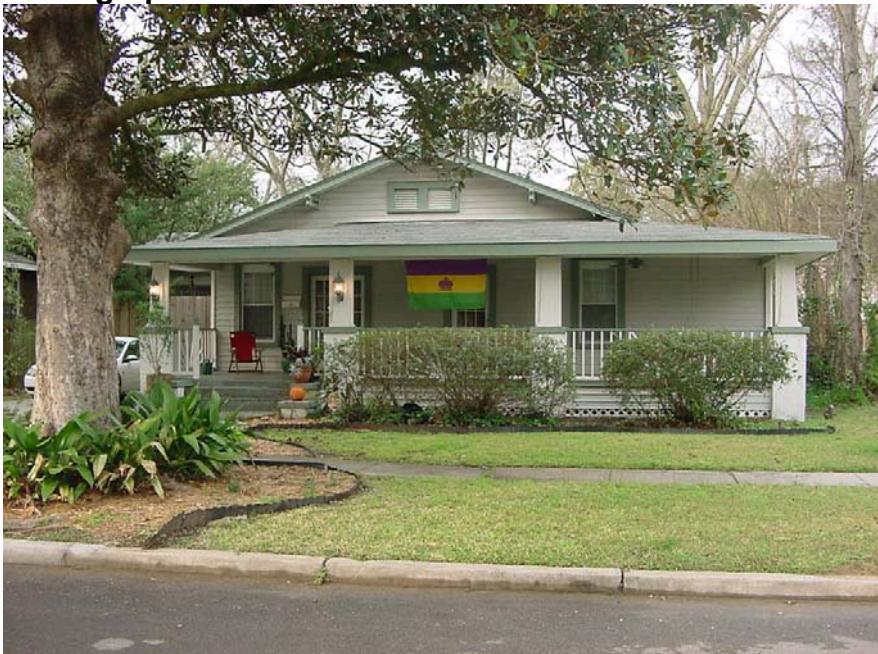
Historic Information: Contributing. 1920s wood frame bungalow now covered in vinyl or aluminum siding. Front gable accented with struts. Porch features slightly splayed posts atop brick piers. Balustrade replaced.

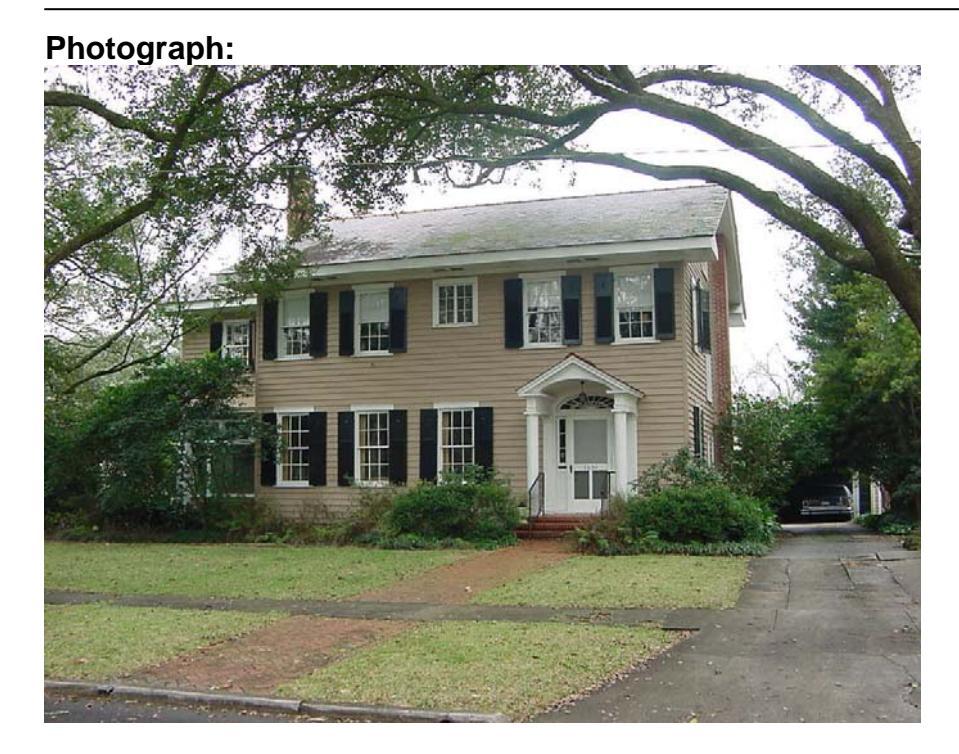
Historic Information: Contributing. 1930s two story wood frame Colonial Revival gable end house. Off center entrance portico features thick posts (replaced) at each corner and a pediment with an elliptical arch following the form of the door fanlight behind it.

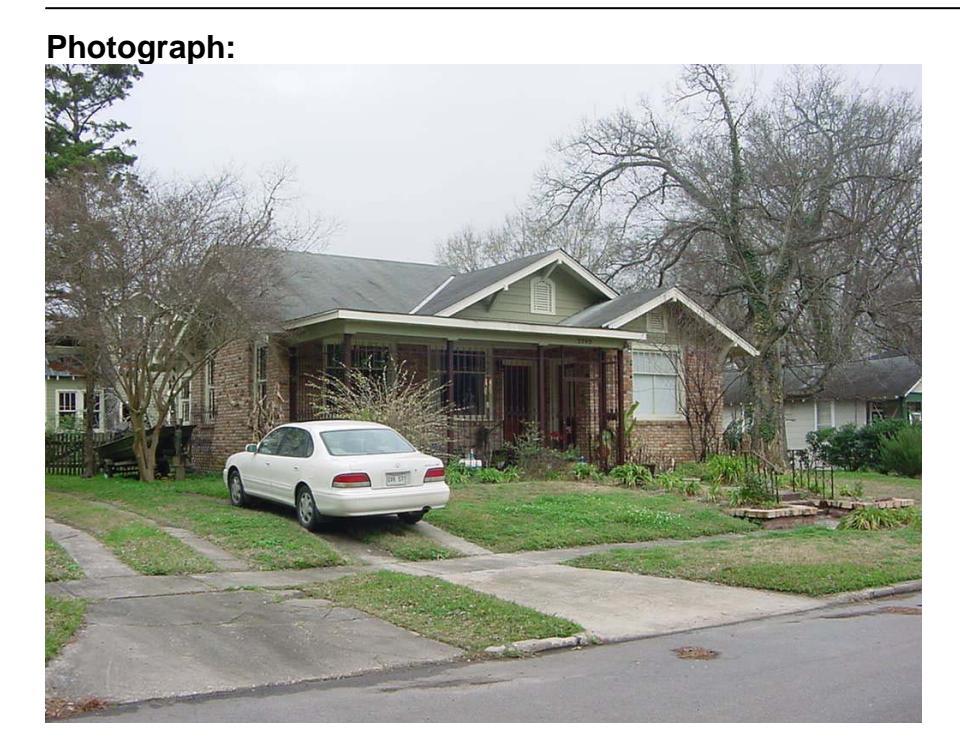
Historic Information: Non-contributing. Severely altered bungalow (porch replaced, bricked over).

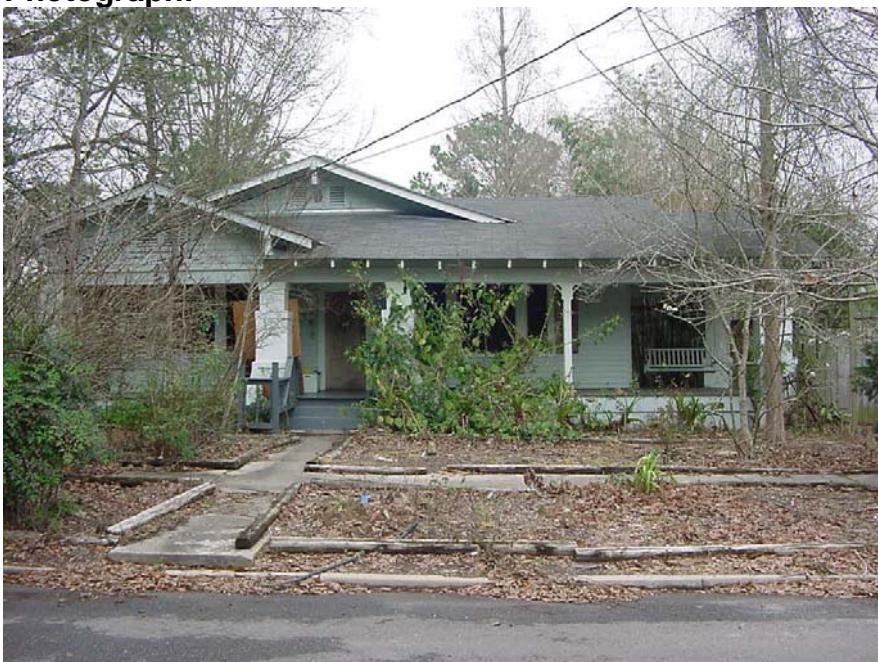
Historic Information: Contributing. 1920s frame bungalow with low-slung bracketed double gables at the façade. Porch features high brick piers with a slightly narrower, short brick pier atop each. One of the pier-atop-pier designs has been inappropriately replaced with a slender wooden column.
